ROAD CONDITION MAPPING WITH HYPERSPECTRAL REMOTE SENSING

Martin Herold,¹ Dar Roberts,¹ Omar Smadi,² and Val Noronha¹

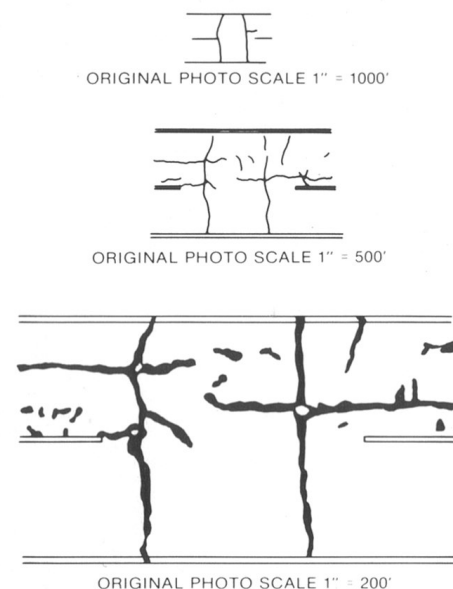
Figure 1: Pavement surface defects mapped from aerial photographs on different scales (Stoeckeler, 1970)

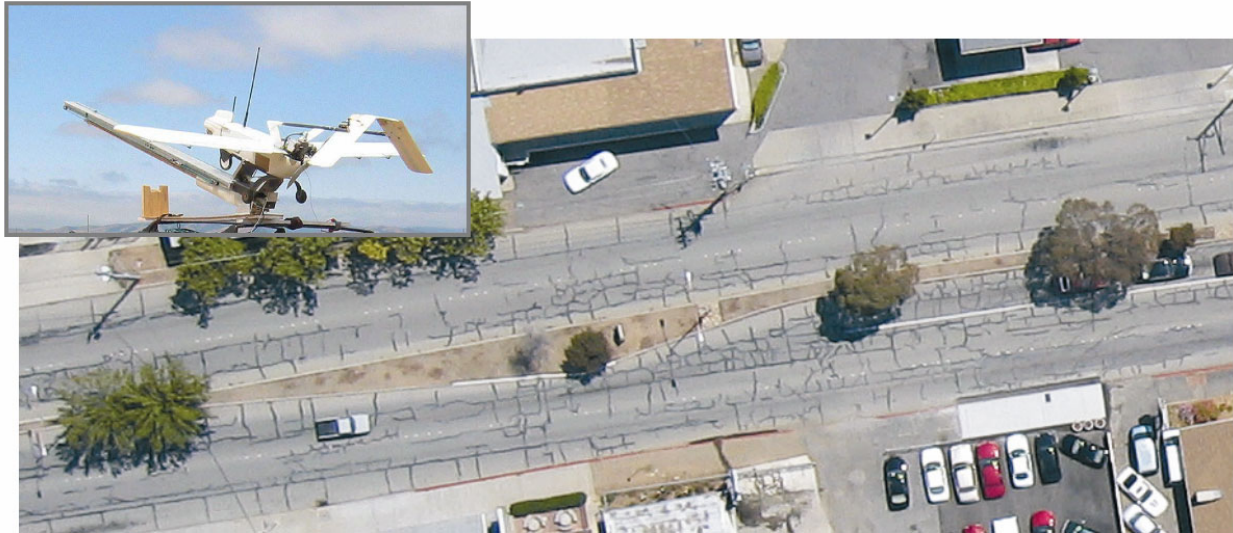
Figure 2: UAV-based observation for visual interpretations of road distresses over Gilroy, California.
(©MLB <http://www.spyplanes.com/>)

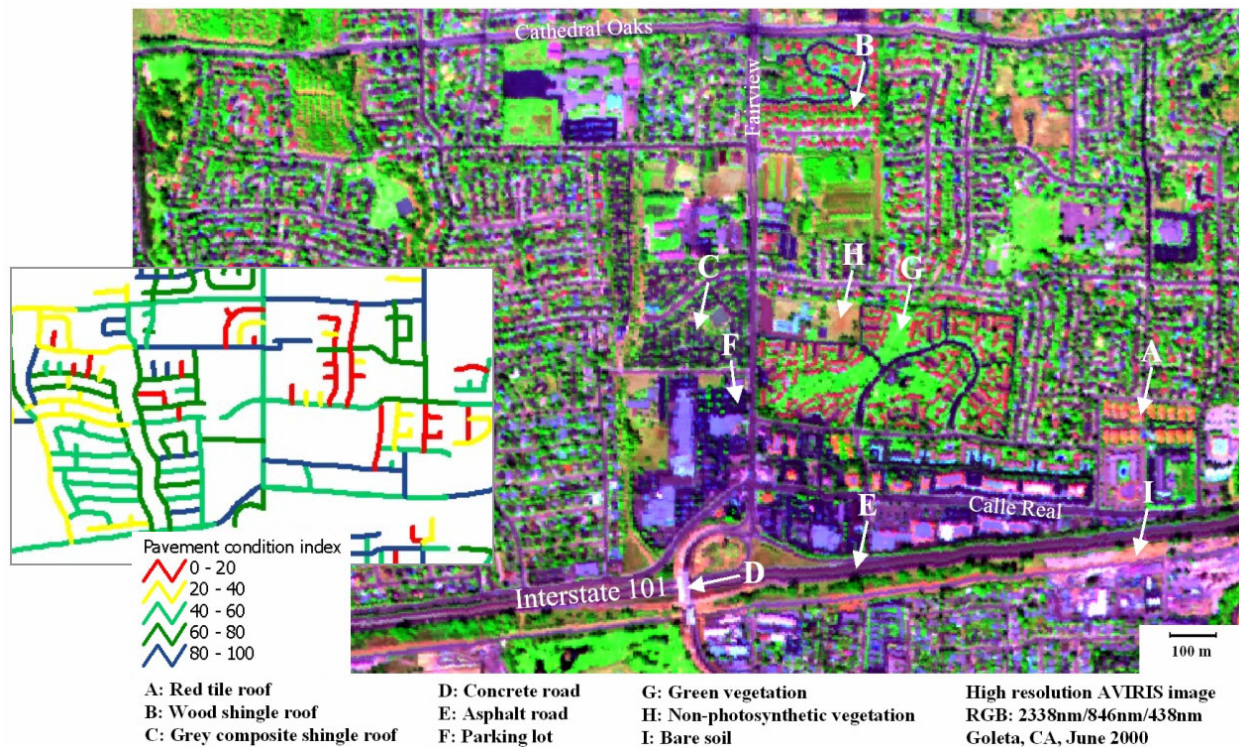
Figure 3: AVIRIS image of the Fairview/Cathedral Oaks study area shown with the distribution of the PCI from the Santa Barbara County database.

The study focused on several roads in the Goleta urban area, located 170 kilometers northwest of Los Angeles in the foothills of the California Coast Range. Figure 3 shows the study area north of Interstate 101. The main roads of interest are Fairview Avenue and Cathedral Oaks and in particular near the intersection of both which is shown in the upper middle part of the AVIRIS image (Figure 3). Both roads have four lanes, two in each traffic direction, and represent major urban roads. The SB County PCI values for these roads show that the roads reflect a large variety of conditions (Figure 3). The eastern part of Cathedral Oaks has a PCI of nearly 100. This road was resurfaced just before the study started. Fairview and the western part of Cathedral Oaks have fair/poor conditions with PCI values on the order of 40-60. Fairview pavement is in particular poor conditions. The central divider of Fairview was the boundary between two traffic management zones. Every rehabilitation effort had to be funded and coordinated by two different institutions. This resulted in delays and failure of necessary maintenance and continued deterioration of the road surface is apparent today.

budget scenarios. The PMS is linked to ArcView GIS and a digital road database that was available for this study. Figure 3 shows a subset of this database. The PCI is reported for relatively large road segments and does not discriminate between different lanes. The “County PCI” was provided for January 2002. In February 2002 the city of Goleta was incorporated and the responsibility of road management went to the new city administration, which did not maintain and update the GIS database.

Two hyperspectral datasets were acquired in the study area. The AVIRIS sensor flew on June 9th, 2000. The data were acquired at a spatial resolution of approximately 4 meters. The AVIRIS sensor acquires 224 individual bands with a nominal bandwidth of 8-11 nm, covering a spectral range from 370 to 2510 nm (Green et al., 1998). The Jet Propulsion Laboratory (JPL) and the University of California, Santa Barbara (UCSB) preprocessed the data for motion compensation and reduction of geometric distortions due to topography. The data were processed to apparent surface reflectance using modified Modtran radiative transfer code and further adjusted using a ground reflectance target from the spectral library (Green et al., 1993). In general, the spatial and spectral quality of the AVIRIS data were excellent (see Figure 3).

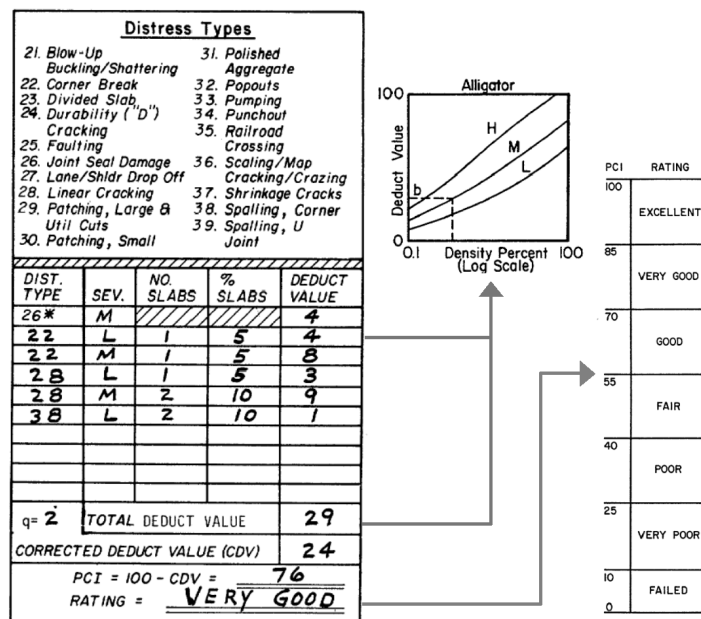
Figure 4: Road condition survey sheet outlined by the U.S. Army Corps of Engineers (1982).

aggregate the information into a Pavement Condition Index (PCI, Figure 4). The PCI is a single road performance indicator with a scale usually between 0 and 100. In this study two expert groups surveyed the roads in June and July 2003 (Fairview and Cathedral Oaks). A qualified pavement expert led the first group from the Center for Transportation Research and Education from the Iowa State University at Ames. The second expert group included representatives from California firms associated with CALTRANS: Independent Seals, Western Paving and Vulcan Paving. The experts were asked to categorize the road condition in five categories (excellent, good, fair, poor and very poor) and suggest a road management action (do nothing, maintenance, minor rehabilitation, major rehabilitation, and replacement).

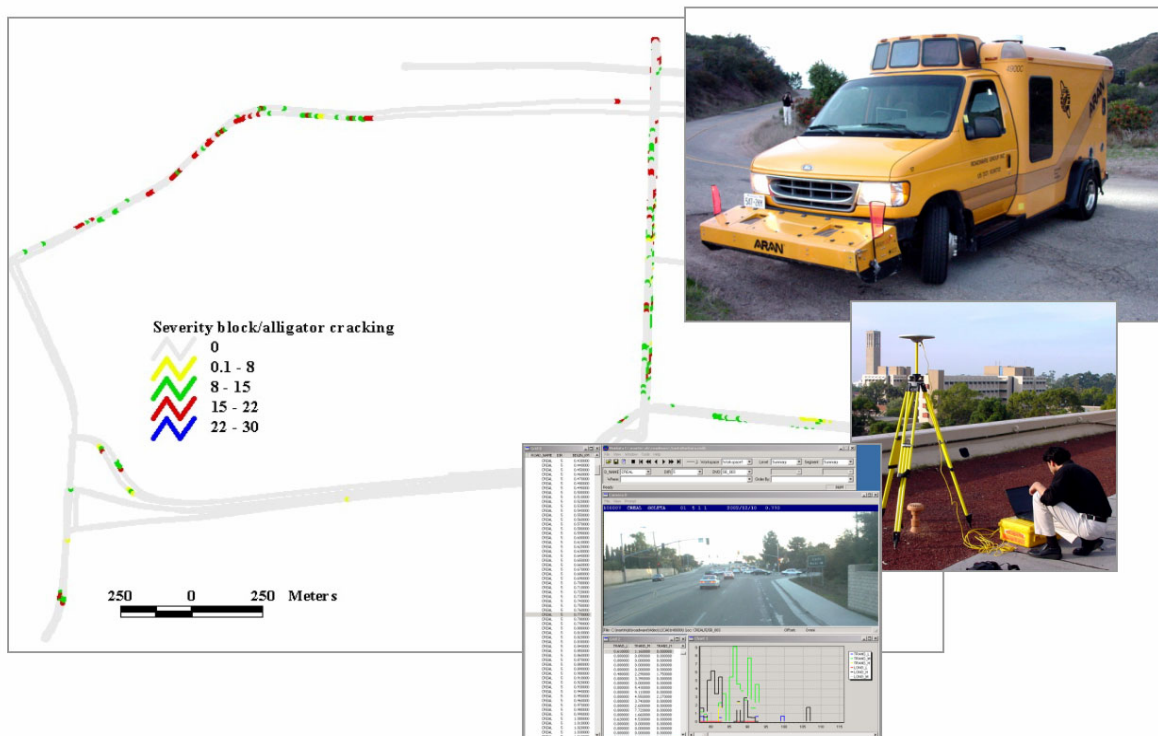
Figure 5: The Roadware pavement health survey with the ARAN survey vehicle, GPS base station, the video/road distress log and the resulting GIS database.

The third survey technique provided very detailed information about road distresses. The observations were performed in December 2002 with the Automatic Road Analyzer (ARAN) of the Roadware cooperation (www.roadware.com). ARAN is mounted on a specially modified vehicle that houses an extensive set of computers and sensors including: lasers, inertial measurement units, accelerometers, ultrasonic transducers, digital cameras and other advanced technology subsystems (Figure 5). GPS on the vehicle and at a base station ensures accurate locational data. The survey provides geocoded road distresses information of over 30 individual parameters aggregated for 10 m road or lane segments. For further analysis the original data were aggregated to 50 m road segments and the individual road distress measures were merged to a PCI and Structure index. Similar to the ones for field surveys, the “Roadware PCI” categorizes the majority of distresses in a rating based on 0 to 100 scale with 100 being the best condition. The PCI calculations are based on deduct values (Figure 4) that come from the actual Roadware observations (see also Figure 4). The structure index works in a similar manner. The only difference is it only considers distresses that are related to the structure, e.g., only alligator, block, and transverse cracking.

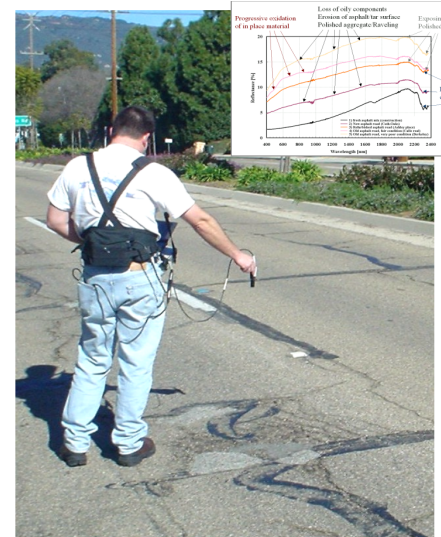
Spectral libraries contain pure spectral samples of surfaces, including a wide range of materials over a continuous wavelength range with high spectral detail, and additional information and documentation about surface characteristics and the quality of the spectra (i.e., metadata). In May 2001 and February 2004 two ground spectra acquisition campaigns were conducted in the study area. Ground spectra were acquired with an Analytical Spectral Devices (ASD) Full Range (FR) spectrometer (Analytical Spectral Devices, Boulder, CO, USA). The FR spectrometer samples a spectral range of 350-2400 nm. The instrument uses three detectors spanning the visible and near infrared (VNIR) and shortwave infrared (SWIR1 and SWIR2), with a spectral sampling interval of 1.4 nm for the VNIR detector and 2.0 nm for the SWIR detectors. FR field spectrometer data are widely used and considered to provide high quality spectral measurements. All targets were documented and integrated into a spectral library (Figure 6). The spectra library contains various types of roads (asphalt, concrete, gravel) and different distresses of asphalt road surfaces.

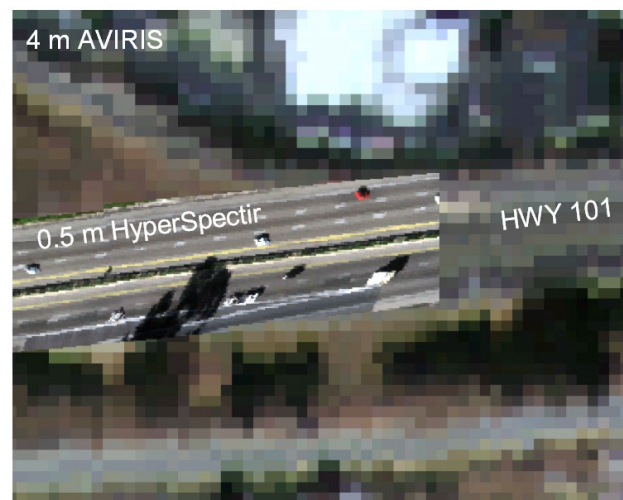
Figure 7: Comparison of spatial detail provided by the AVIRIS and HyperSpecTIR sensor.

concluded that AVIRIS data did not allow for mapping of road conditions in this study. This limitation can be related to the spatial resolution. Figure 7 emphasizes the spatial detail provided by the AVIRIS sensors. Pure road surface pixels are rare and surrounding land cover types (vegetation, gravel, buildings etc.) affect the spectral signal and add significant variability and uncertainty to analysis of road conditions (Figure 12).

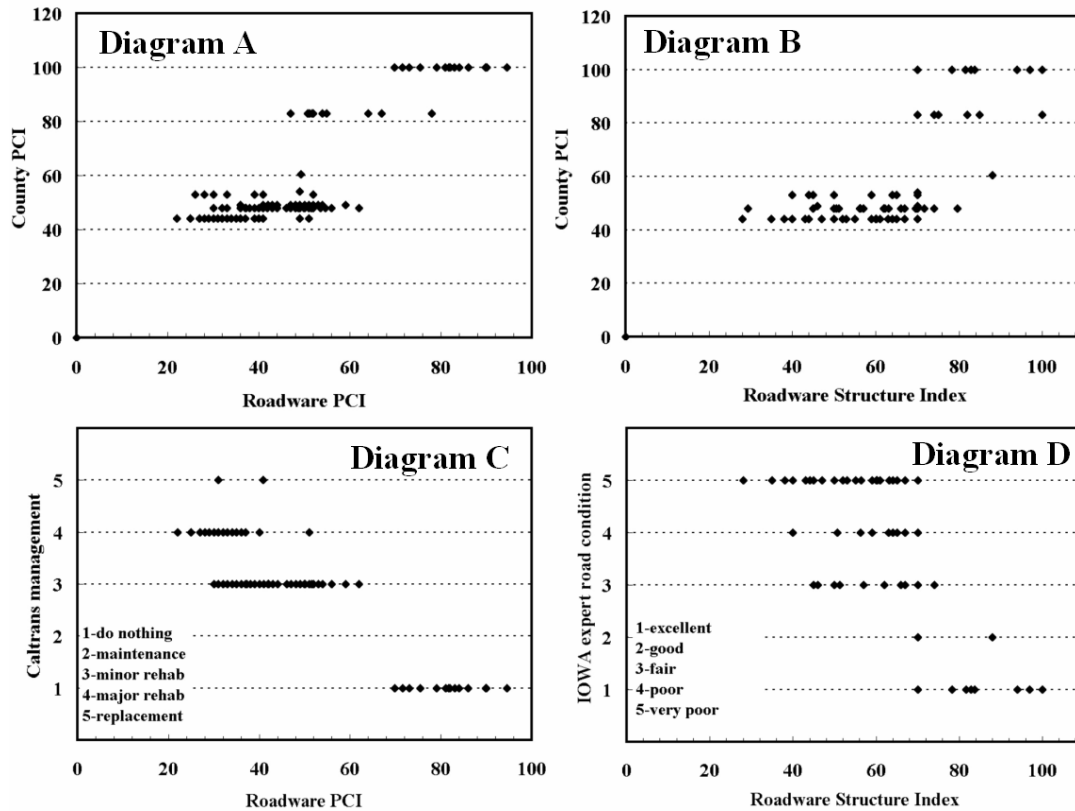
Figure 8: Comparison of road condition survey data (Note: The y-axes of diagrams C and D are categories.)

All three road survey techniques (expert visit, Roadware, County PMS) applied in this study can be considered part of the “common practice” in pavement management. Although the individual surveys have slight differences in time of acquisition and spatial unit (extend of road segments), the data can be compared to explore similarities and differences among them (Figure 8). Diagram A and B compare the County PCI to the Roadware PCI and structure index. There is a good linear relationship between both PCI measures. One large County road segment contains several smaller Roadware segments and the variability in the Roadware PCI emphasizes the road condition variability within the larger County segments. The relationship between County PCI and Roadware structure index is non-linear (Diagram B). This is expected since the structure index only contains the structural damages. Early pavement degradation usually does not result in severe structural damages and the structure index remains high. The structure index better describes distresses for roads in poorer conditions with significant structural damages, i.e., there is quite some variability in lower structure index values with the County PCI staying fairly constant. Diagrams C and B in Figure 8 relate the expert opinions to the Roadware data. Both show good relationships. The Roadware PCI clearly reflects the difference between a very good road (“do nothing”) and the roads that need rehabilitation or replacement. A similar distribution is shown in Diagram D. Although the overall relationships between the different survey techniques is obvious, there is a fair amount of variability and disagreement in particular for roads in poorer conditions. Consequently, the “common practice” techniques are not completely congruent and reliable. Every decision based on these will require some kind of compromise especially for approaching expensive rehabilitation or replacement projects.

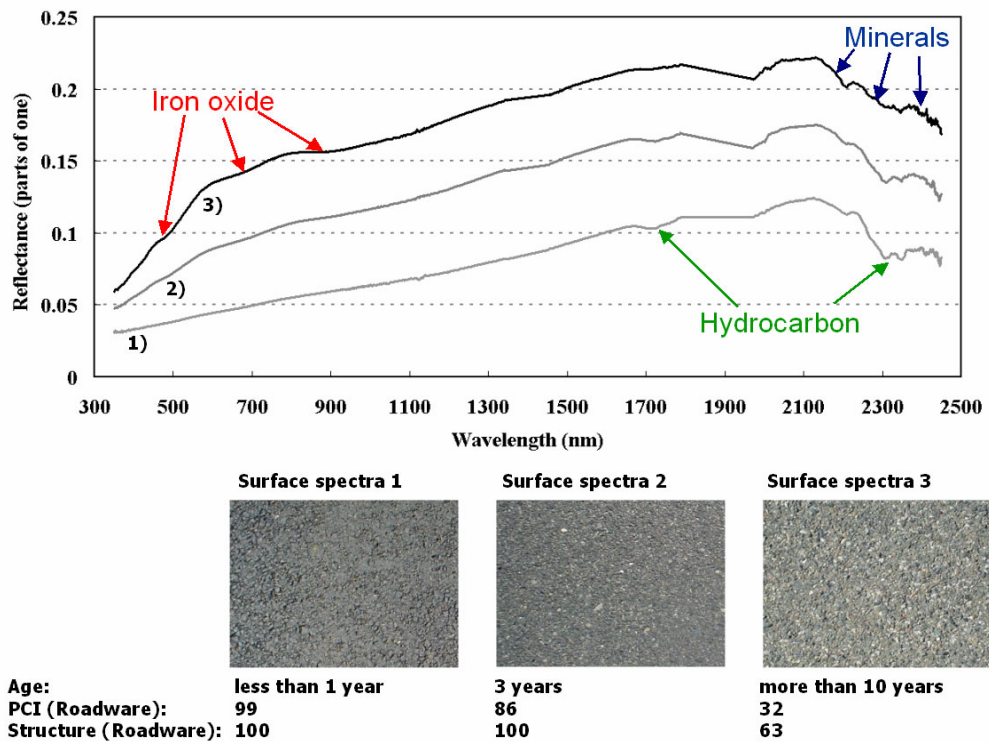
Figure 9: Spectral effects of asphalt aging and deterioration from the ASD ground spectral measurements (the major water vapor absorption bands are interpolated).

The spectral signal from different types of road materials such as concrete and asphalt are different and hyperspectral sensing can easily distinguish between them (Herold et al., 2004). This study focuses on the variability within asphalt road surfaces i.e., the spectral effects of aging and deterioration of asphalt pavement (Figure 9).

The natural aging of asphalt is caused by reaction with atmospheric oxygen, photochemical reactions with solar radiation, and the influence of heat, and results in three major processes (Bell, 1989): the loss of oily components by volatility or absorption, changes of composition by oxidation, and molecular structuring that influences the viscosity of the asphalt mix (steric hardening). The loss of oily components is relatively short-term; the other two are more long-term processes. The results of these processes are represented in the spectra. New asphalt surfaces have the lowest reflectance with a linear increase in reflectance towards 2100 nm. The surface is nearly completely covered with asphalt mix (spectrum 1). Hydrocarbon absorptions are evident at ~1750 nm and above 2100 nm with a significant doublet at 2310 and 2350 nm (Cloutis, 1989). As the pavement ages and its condition deteriorates, reflectance increases in all parts of the spectrum. The asphalt mix seal starts eroding exposing the rocky components of the pavement (spectrum 2). This process continues until the rocky components dominate the asphalt surface. With the erosion of the asphalt mix the road surface is less viscous and more prone to structural damages like cracking. This decreases asphalt mix absorptions resulting in a significant increase in object brightness. This difference is highest in the NIR and SWIR with more than 10% reflectance. The spectral shape in NIR and SWIR changes from slightly concave for new asphalt to more concave for older surfaces. The oxidation process and exposing of rocky components is clearly shown by the appearance of iron-oxide absorption features at 520, 670 and 870 nm in spectra 2 and 3. The hydrocarbon features are only distinct for new asphalt surfaces and vanish with age and poorer surface conditions. Furthermore there is significant change in slope in the transition from hydrocarbon to mineral absorption. For older roads the slope increases between 2100-2200 nm and decreases between 2250-2300 nm.

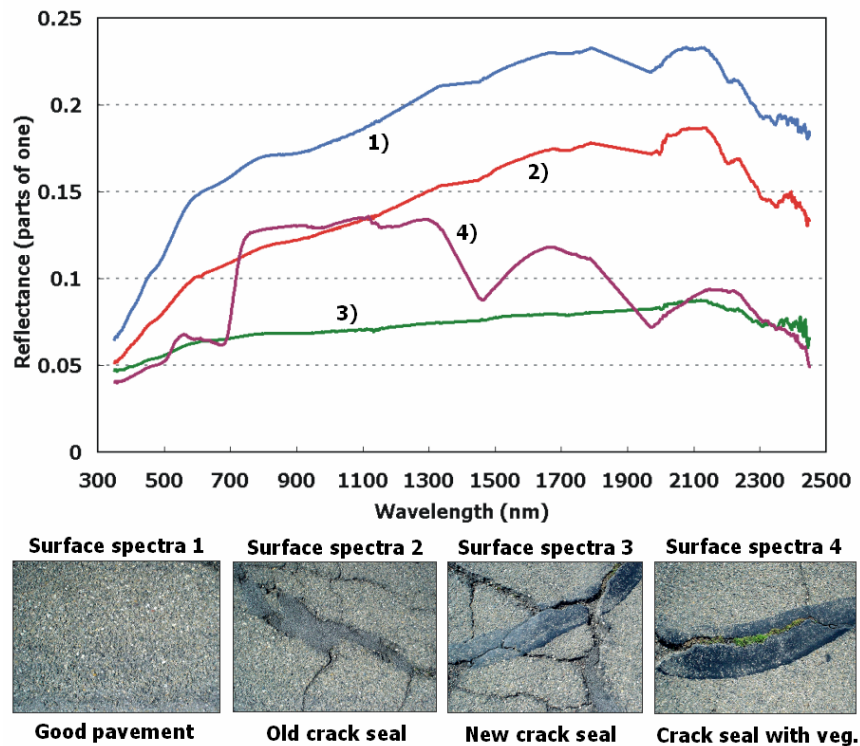
Figure 10: Spectral effects of different structural road damages from the ASD ground spectral measurements (the major water vapor absorption bands are interpolated).

Spectral characteristics of specific road damages are presented in Figure 10. The spectra show that cracks and old crack seals produce decreasing brightness. For new crack sealing, this effect is more dominant and results in near constant low reflectance similar to the ones found for parking lot surfaces (Herold et al., 2004). Some older cracks contain green vegetation, which again has a strong impact on the spectral response exposing typical spectral features from chlorophyll, water content and lingo-cellulose.

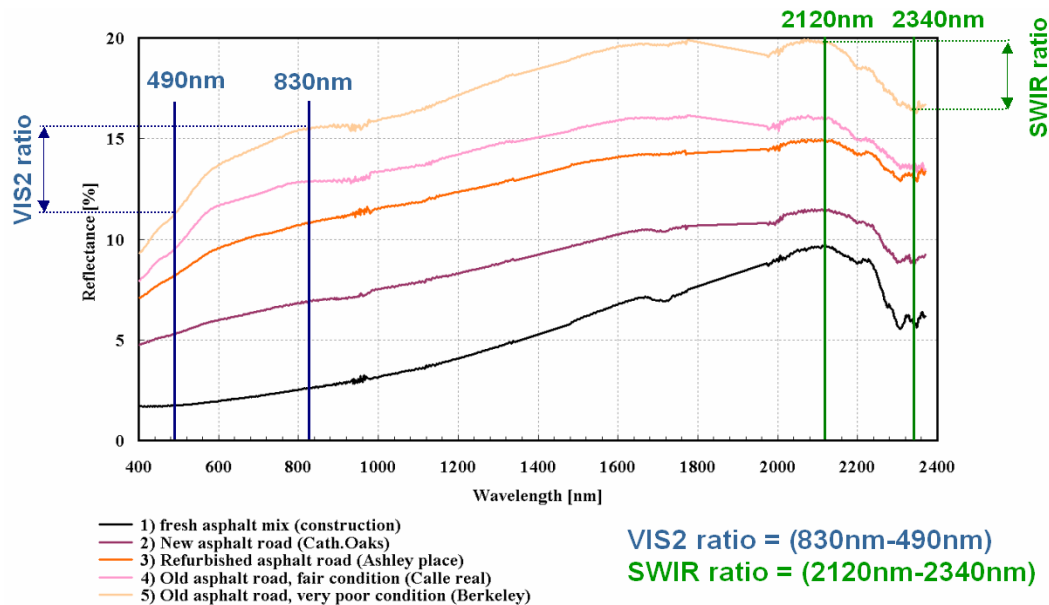
Figure 11: Two image ratios used for the hyperspectral data analysis shown with ASD ground spectra of different asphalt road surfaces.

Spectral analyses of road surfaces suggest several features that have utility for spectral identification of road aging and deterioration. The coarse spatial resolution of the AVIRIS data and the spectral quality of the HST data, however, only allowed for the use of very general spectral features, i.e., small absorption features were excluded from the hyperspectral data analysis. The investigations were based on two image ratios (Figure 11).

These ratios emphasize the increasing brightness and the change towards more concave spectral shape in the VIS for older roads. The first ratio (VIS2) represents the reflectance difference between 830 nm and 490 nm. This ratio is low for new asphalt surfaces and increases with age and level of deterioration, partially caused by the iron oxide absorptions. The SWIR ratio reflects the spectral contrast between ~2120 nm and ~2340 nm, which decreases for older asphalt surfaces (Figure 9 and 11). The AVIRIS based image ratios were compared to the County PCI values (Figure 12). The graphs show a large amount of variation in the ratios versus the PCI values. There is some indication of the expected decrease in image ratios for higher PCI values. The variability of the ratios seems to increase for roads with lower PCI. However, the relationship is very weak (R-squared values in the order of 0.1-0.2) and it can be

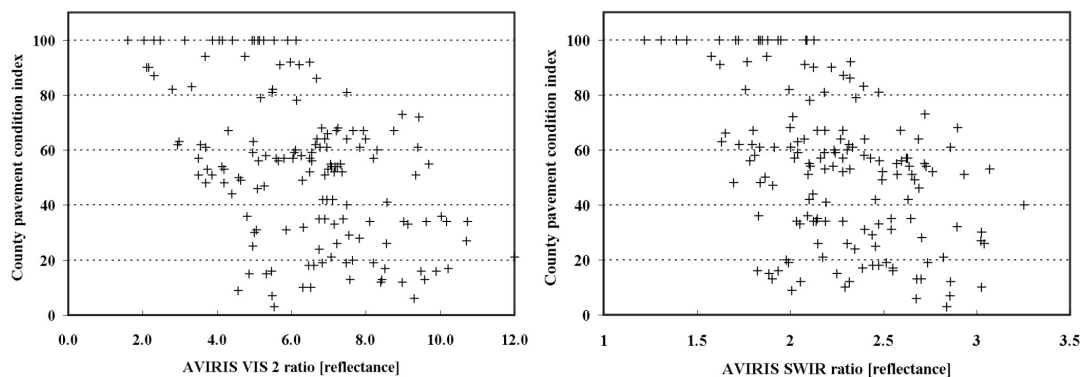
Figure 12: Comparison of two AVIRIS-based image ratios versus the County PCI.

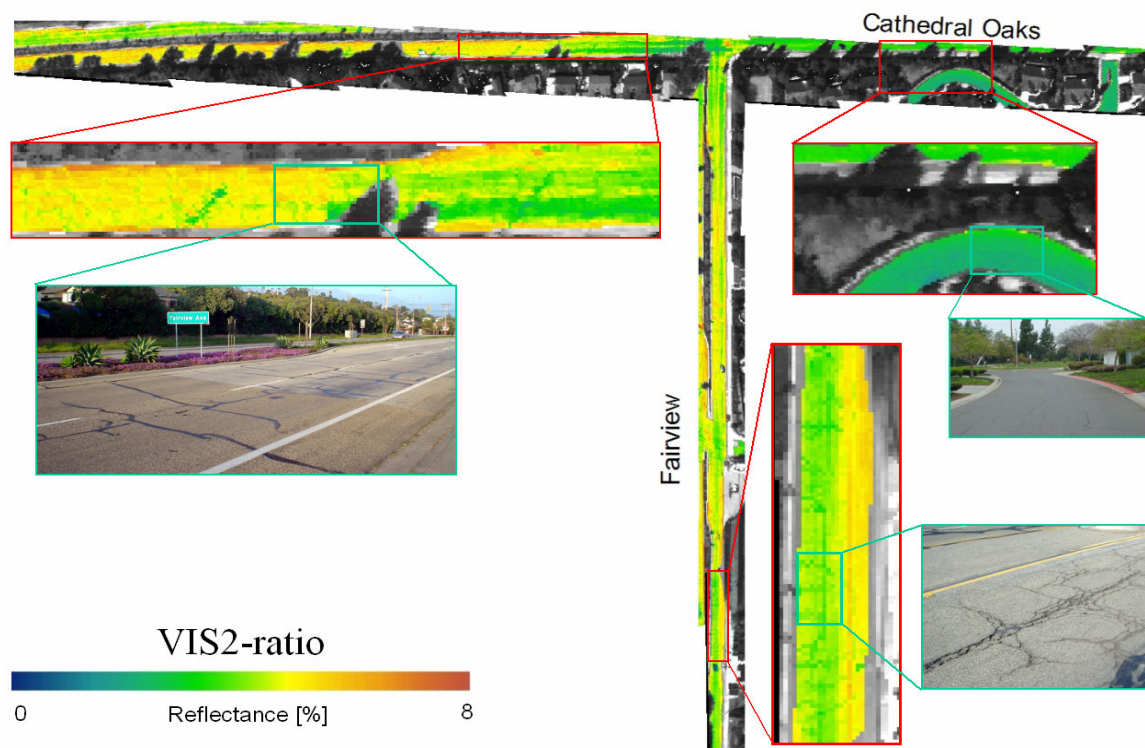
Figure 13: Spatial distribution of the VIS2 ratio derived from the HST data.

The HST analysis only focused on the VIS2 ratio since the spectral quality of the data limited the investigations on the VIS-NIR region. The spatial resolution was very beneficial since road surface features and distresses are represented in the HST data (Figure 13). The spatial distribution of the VIS2 ratio showed expected general road surface pattern. Roads with recently paved surfaces (upper left part of Figure 13, east Cathedral Oaks) show low ratio values on the order of 2-4 % reflectance difference (dark green and blue) between 830 and 490 nm. The highlighted part of west Cathedral Oaks presents the transition between a newer split-seal refurbished road (green-yellow) and an older part with several sealed transverse cracks (yellow-orange). The southern part of Fairview shows an area with severe alligator and block cracking. The crack patterns are visible in the VIS2 distribution with lower ratio values (see Figure 10). This adds spatial variance to the ratio values and appears for roads with structural damages.

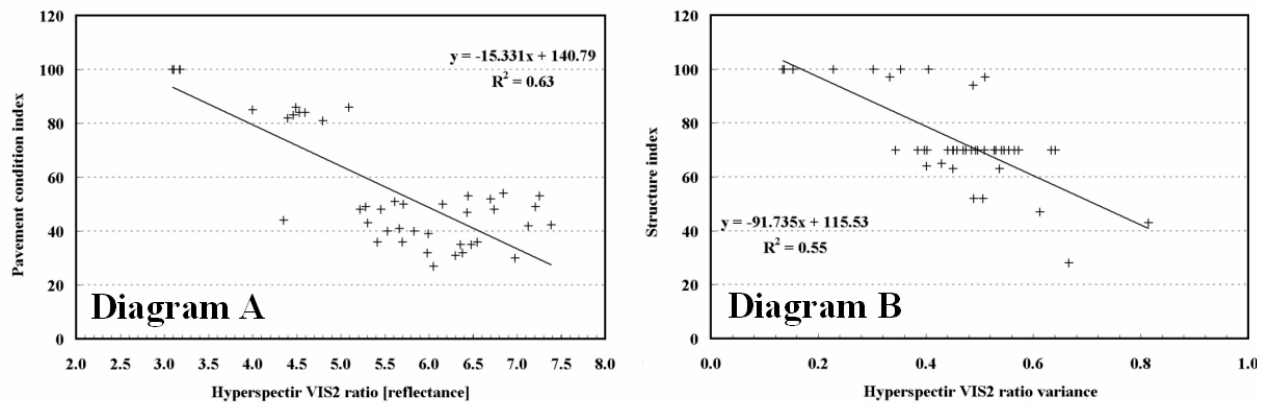
Figure 14: Comparison between HST VIS2 ration and Roadware PCI and structure index.

The HST VIS2 values show a significant correlation with the Roadware PCI values (Figure 14, Diagram A). For roads in good condition the relationship is very distinct. The variability increases for high ratio/low PCI values, hence to spectral signal of the roads get more complex and the relationship is not as obvious. Diagram B shows the spatial variance in the VIS2 ratio versus the Roadware structure index. This relationship represents the fact that structural road damages add complexity to the spectral signal. There is, however, significant variability for very high PCI values. They are false positives, basically other features that add variability to the spectral signal and do not represent road damages such as shadows from light poles, cars etc.

The statistical relationships in Figure 14 are strong enough to convert the remote sensing signal (VIS2 ratio, VIS2 ratio variance) to road condition parameters (PCI, structure index). The spatial distributions

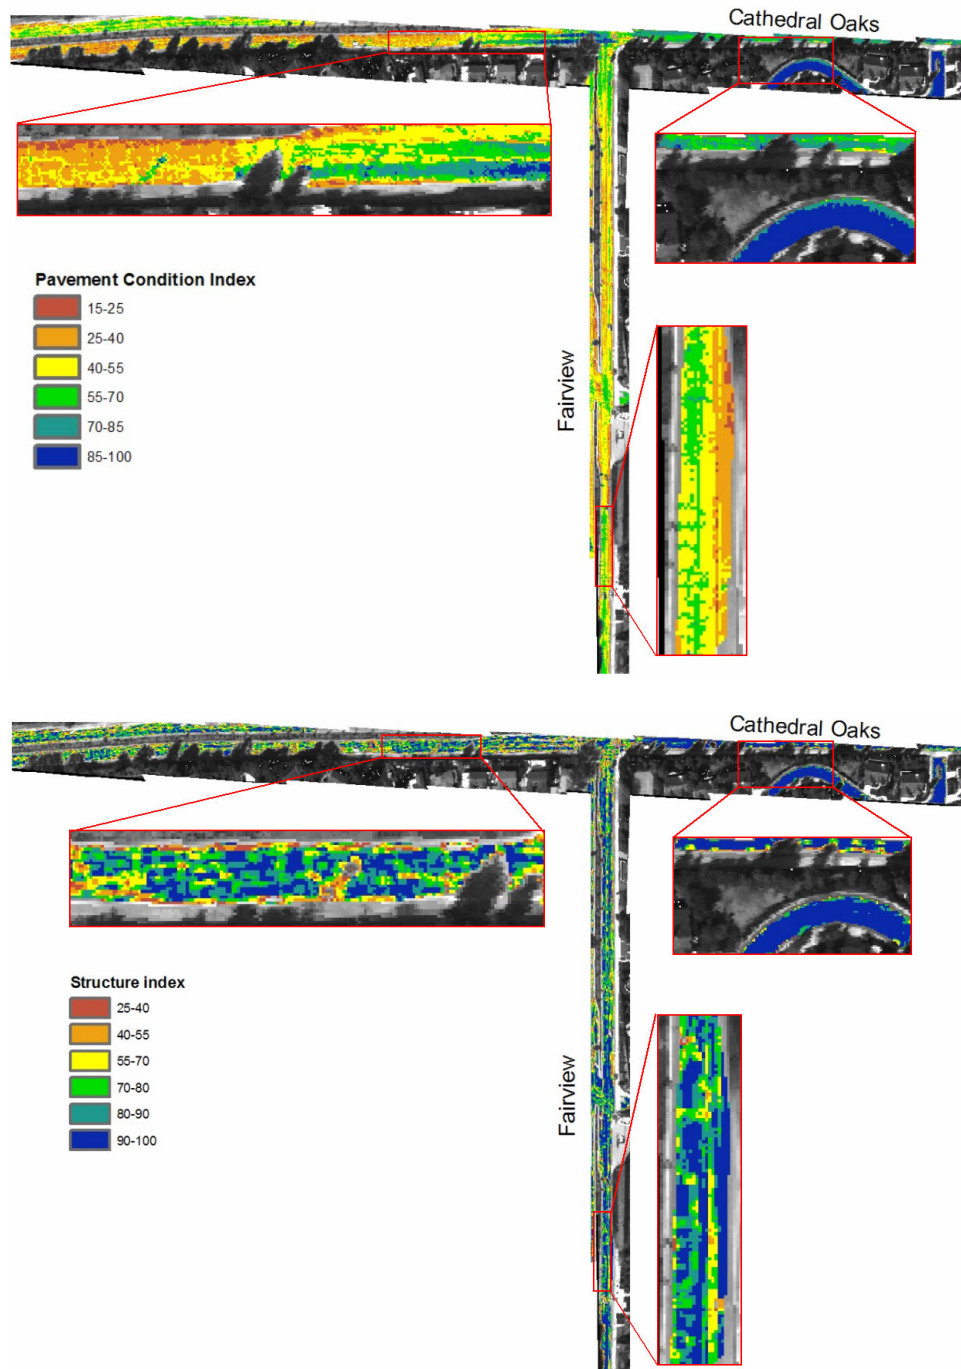
Figure 15: Spatial distribution of PCI and structure index derived from HST data.

are shown in Figure 15. The PCI patterns highlight recently paved roads with high values (see Figure 13). Road surfaces in poorer condition show lower PCI values and higher variability. Specific cracking patterns are revealed in the highlighted area of Fairview. The structure index was derived from the local VIS2 ratio variance. The spatial distribution emphasizes local pattern of road surface variability caused by structural damages. In the areas of newly paved roads in the upper left on the bottom map, there are some small high-variance features near the edges of the roads that are not road distresses representing false positives. Cracking patterns and other distresses are reflected in the other highlighted areas on Fairview and west Cathedral Oaks which show high variance.
